## The Box of Mossy Gears

### MEMO XK120 Moss Gearbox Problem

Date: August 31, 1993

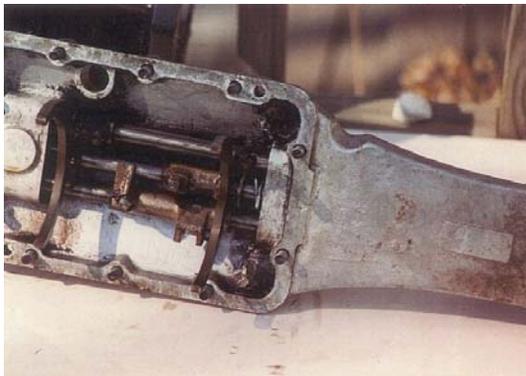
*Top cover with washer and wire on middle shaft added by DPO*

On investigating further I discovered a spacer/washer on the 1st/2nd fork actuator rod that isn't in the parts list. It has the effect of reducing the rearward travel of the fork into 1st. Also, the locking wire on the setscrew for the 1st/2nd fork was a different color than all the other locking wires. Aha! Some Previous Owner has been messing with the fork, maybe to fix the same problem. Now to figure out what he did, he must have added the washer, maybe he replaced some parts with newer parts? I sought help from other Jaguar owners on the Internet.

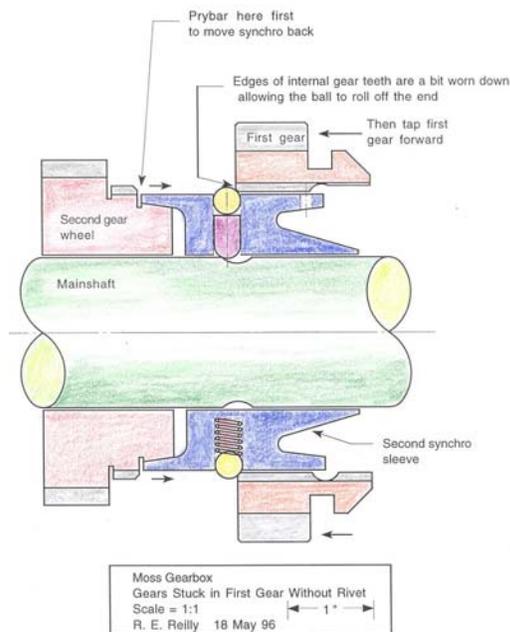
*Pry first gear forward while pushing the syncro sleeve backwards."*

My workabout solution in the E-type is to shove the gear selector all the way back in first and rattle it back and forth (with a little more force on the "back") until it suddenly is able to go to neutral as if nothing had happened at all. From the amount of force that results in no action, you'd be surprised at how light a shaking unsticks things. When first gear is fully engaged, the six spring loaded balls and the one interlock ball should protrude a bit from the syncro sleeve. You can measure what Jaguar designed in, and it's a frighteningly large percentage that hangs out! As long as the ball's point of contact is inside the syncro sleeve, I believe you're okay.

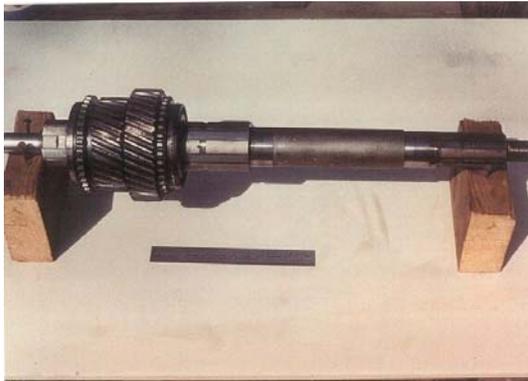
*Mainshaft with damage forward of dimple caused by hammering on first gear*

I took the gearbox apart and found that on the internal teeth of the first speed wheel with the relieved tooth, the unrelieved part of this tooth had been deformed into a furrow shape by the ball/plunger riding against it. There was a corresponding dimple on the mainshaft caused by the other end of the plunger. Thus I at least knew why it took a blunt nose chisel and a big hammer to get it out of first gear, and I now knew why the thing was popping out of second gear. That tooth was thus wider than it should be, and it was too wide to engage properly with the external teeth on the rear of the second gear wheel, thus preventing the first speed wheel from moving all the way forward into second gear engaged position. That wide tooth I filed off back to normal width, so it would go into second and not pop out anymore.

I now see it would have been better if I had tried to prybar the second speed synchro sleeve back to the rear, instead of beating the first gear wheel forward. The furrowed tooth and dimpled mainshaft appear to be due to my hammering. I thought these gears were supposed to be harder than a woodpecker's lips, but apparently not.

I decided to machine a relief in the tooth exactly opposite to the one relieved tooth, thus making the second tooth the same as the first tooth originally was. Then I could install the first speed wheel on the second speed synchroniser sleeve 180 degrees from where it was. These can go on the mainshaft any of six ways, so it would be necessary to assemble them in one of five ways so the ball/plunger will not pass over the damaged dimple on the mainshaft.

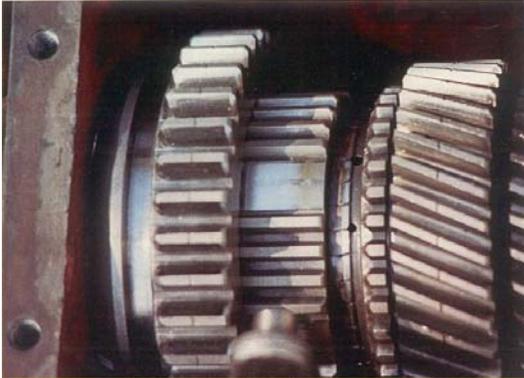
*Box in first gear with second synchro sleeve pulled back by the stop pin, second gear wheel synchro cone visible*

The internal cone of the second speed synchro sleeve and the external cone of the second gear wheel were burned and some metal has been abraded. This is likely due to the two trying to synchronise together while the thing was stuck in first gear, which they couldn't do because they were moving at different speeds. So now I regret having driven home that quarter mile stuck in first.

Now to turn my attention to the problem of poor synchromesh in second gear. The second synchro sleeve and the second gear wheel synchro cones were worn, and some metal was built up in the grooves in the second gear wheel cone. I chipped this out, then tried them together. There is supposed to be a gap between the front face of the sleeve and the rear face of the wheel, but there was none. This meant the sleeve internal cone was worn so bad that it was not rubbing effectively on the wheel external cone, instead the vertical faces were rubbing. I put the sleeve in a lathe and turned off .025" off the front face. Now it seems about right. Then I lapped the cones together using valve grinding paste, rubbing them together until they seemed to "get a good bite" in the words of the manual.

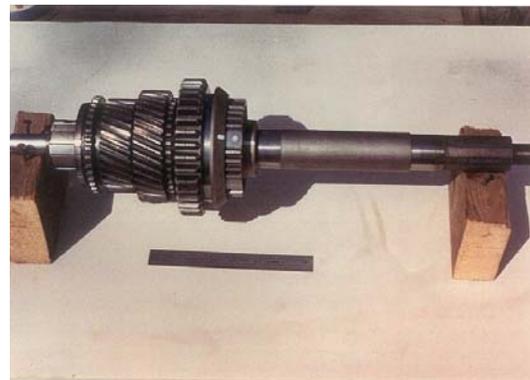
*Mainshaft with stop pin visible between paint marks in the second synchro sleeve*

The stop pin is nothing more than an ordinary rivet, short enough to allow the relieved part of the one special internal tooth in the first gear to pass, but long enough to stop the unrelieved part of this tooth. This rivet has about a 1/8" diameter solid shank. It is stuck through a drilled hole in the outer "rim" of the second synchro sleeve, centered 3/16" from the rear of the rim, in line with the plunger hole, and hammered down a bit to keep it from falling out.

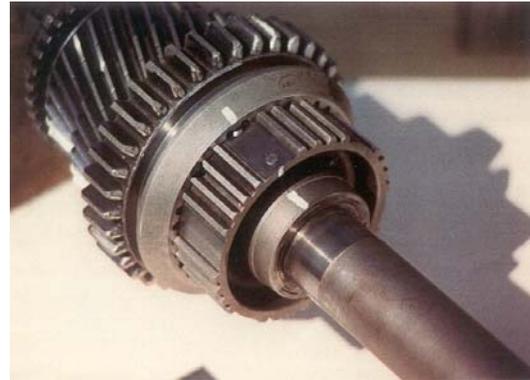
*Second synchro sleeve with stop pin rivet added between paint marks. This was added to all gearboxes from Dec 1952 to prevent overtravel when shifting into first; reference Service Bulletin No. 116*

I determined that the hole for the stop pin rivet should be centered at 0.923" from the center of the plunger hole. This is based on my rivet being 0.141" stock diameter and being mashed down to 0.180" diameter.

Did I say something was harder than woodpecker lips? It's the second synchro sleeve. I could just barely scratch centerlines with my scribe, and the center punch just flattened its point when I tried to centerpunch for the hole. Ordinary high-speed drill bits didn't make a dent. I set up the sleeve in a Bridgeport mill, then used a letter O drill bit (0.316") to find the plunger hole center and set it to zero, then moved the table over 0.923". I used a carbide centering drill to start the rivet hole, then a carbide end mill to finish the hole.

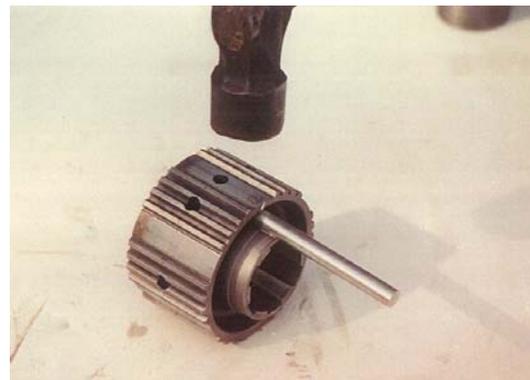
*Hammer and backing tool for flattening out  
the stop pin rivet in the second synchro  
sleeve*

I installed the rivet by using a piece of steel ground into the shape of a wedge that would fit between the rivet head and the neck of the sleeve, then hammering out the shank to 0.180" diameter, then filing it down so the first gear wheel would just clear over it. I tapered the front edge slightly so it wouldn't stick. Feels right, and looks right.
