## The Box of Mossy Gears

### MEMO XK120 Moss Gearbox Problem

Date: August 31, 1993

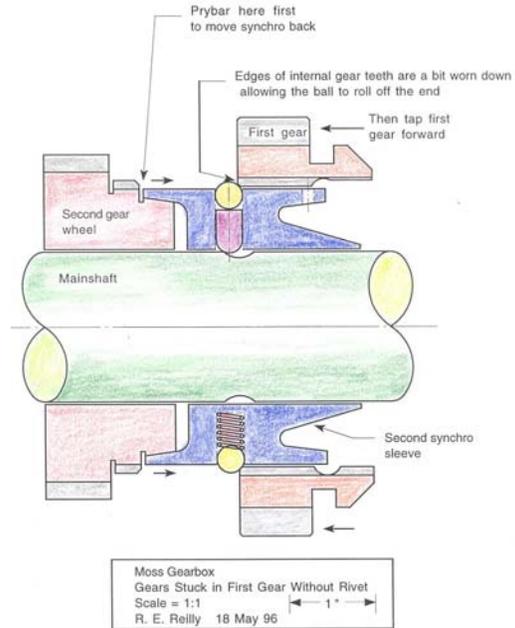
*Mainshaft with damage forward of dimple caused by hammering on first gear*

I took the gearbox apart and found that on the internal teeth of the first speed wheel with the relieved tooth, the unrelieved part of this tooth had been deformed into a furrow shape by the ball/plunger riding against it. There was a corresponding dimple on the mainshaft caused by the other end of the plunger. Thus I at least knew why it took a blunt nose chisel and a big hammer to get it out of first gear, and I now knew why the thing was popping out of second gear. That tooth was thus wider than it should be, and it was too wide to engage properly with the external teeth on the rear of the second gear wheel, thus preventing the first speed wheel from moving all the way forward into second gear engaged position. That wide tooth I filed off back to normal width, so it would go into second and not pop out anymore.

I now see it would have been better if I had tried to prybar the second speed synchro sleeve back to the rear, instead of beating the first gear wheel forward. The furrowed tooth and dimpled mainshaft appear to be due to my hammering. I thought these gears were supposed to be harder than a woodpecker's lips, but apparently not.

I decided to machine a relief in the tooth exactly opposite to the one relieved tooth, thus making the second tooth the same as the first tooth originally was. Then I could install the first speed wheel on the second speed synchroniser sleeve 180 degrees from where it was. These can go on the mainshaft any of six ways, so it would be necessary to assemble them in one of five ways so the ball/plunger will not pass over the damaged dimple on the mainshaft.

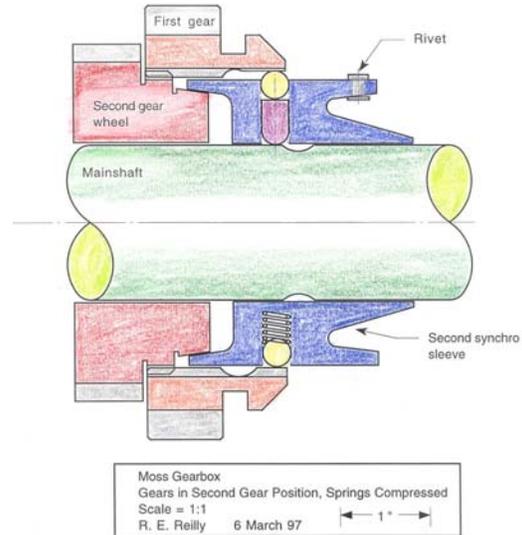
The internal cone of the second speed synchro sleeve and the external cone of the second gear wheel were burned and some metal has been abraded. This is likely due to the two trying to synchronise together while the thing was stuck in first gear, which they couldn't do because they were moving at different speeds. So now I regret having driven home that quarter mile stuck in first.

In studying my box of Mossy gears, I think I am faced with a combination of normal wear and a basic design flaw. They were working together to allow the second synchro sleeve to move forward when the first gear was too far back.

Now to turn my attention to the problem of poor synchromesh in second gear. The second synchro sleeve and the second gear wheel synchro cones were worn, and some metal was built up in the grooves in the second gear wheel cone. I chipped this out, then tried them together. There is supposed to be a gap between the front face of the sleeve and the rear face of the wheel, but there was none. This meant the sleeve internal cone was worn so bad that it was not rubbing effectively on the wheel external cone, instead the vertical faces were rubbing. I put the sleeve in a lathe and turned off .025" off the front face. Now it seems about right. Then I lapped the cones together using valve grinding paste, rubbing them together until they seemed to "get a good bite" in the words of the manual.

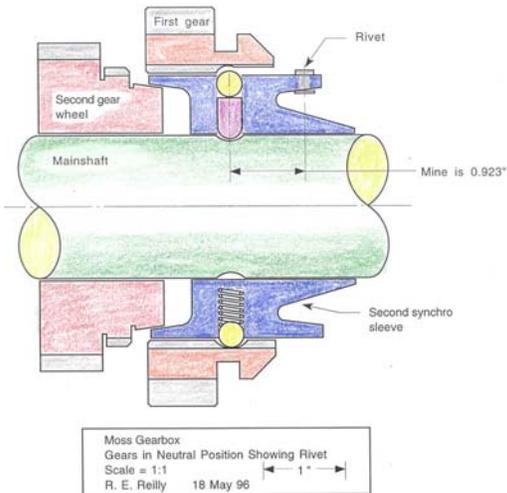
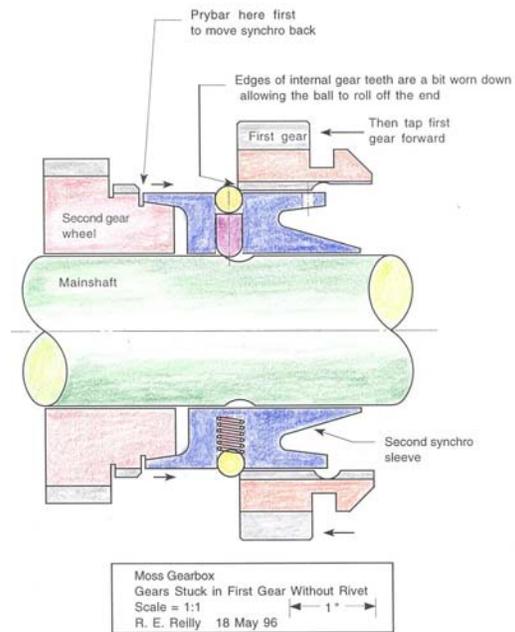
First to be explored was the possibility of a worn ball/plunger. The balls are all .3125" diameter. The plunger is .3122" dia. and .4895" long, with one spherical end and one flat straight-cut end. Adding the ball and plunger together = .802" The mainshaft is 1.645" dia. at the dimples.

The ID of the first gear at the peaks of the internal teeth is 3.250". That leaves a space between of .8025", so the problem is not a worn plunger.

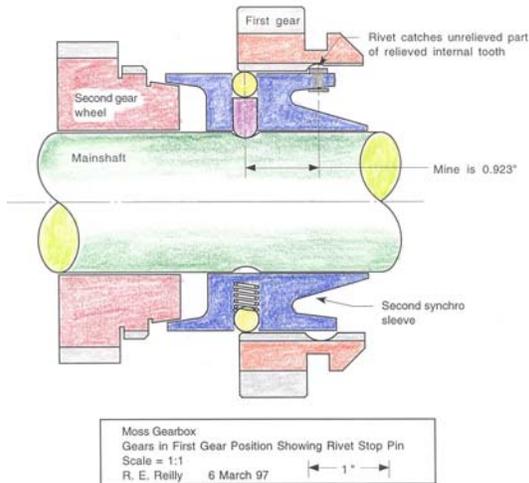
The idea is to stop the first gear just short of where the ball plunger would roll off the forward end of the internal tooth. But that forward end is now a bit worn off from engaging second gear.

My plan was to try to drill a hole in my second synchro sleeve and put in a rivet, but first I had to double check the location was right for it to stop my first gear. Can't assume the Mark 1 is exactly-exactly the same.
